# CONCENTRIC SLAVE CYLINDERS

## TSB-167

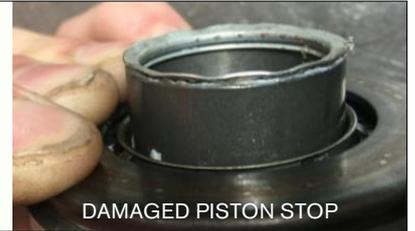
If a piston is over stroking this can cause damage to the end of the guide tube or even to the piston seals. Over stroking can be caused by several things such as incorrect pedal adjustment or incorrect clutch fitment causing low installed height.

DAMAGED SEAL

DAMAGED PISTON STOP

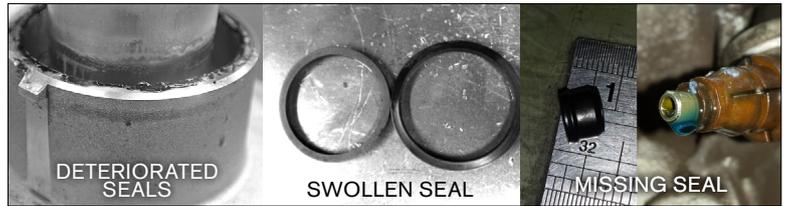
Whenever a hose/pipe is disconnected from the slave cylinder, ensure that the seal/O-ring has come out as well and inspect it carefully. If the seal is swollen or damaged it will need to be replaced. Damaged seals can cause leaks or deteriorate and induce blockages in the slave cylinder or lines resulting in a hard pedal.

DETERIORATED SEALS

SWOLLEN SEAL

MISSING SEAL
